**Flood Control Project Maintenance
Levee Inspections**

Maintenance Issue Types Only, Levee Inspection Report By Mile - Spring 2018

Sutter Maintenance Yard Maintenance Area 0013

Waterway	Bank	Unit Miles	Inspection Start/End	Inspector
Unit No. 01 Cherokee Canal	Right	18.19	04/17/2018 04/17/2018	Bob Duffey

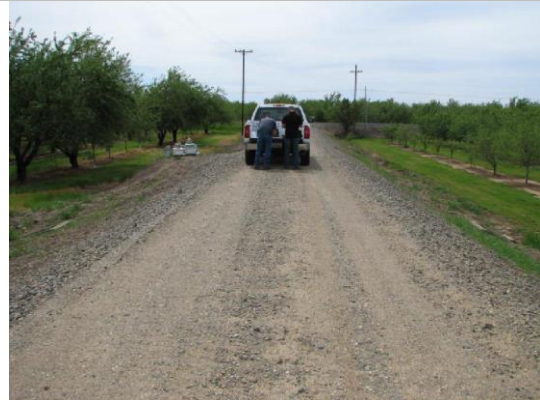
Photo 1 of 3 : UCIP_SP_2018_52180_66689.jpg

Comment Code					
Inspector Comment					
FS_ID:52180 DS_ID:16343 EP_NO: N/A Repair Type: No Action Needed Crossing Status: Found UCIP Comments: 6/14/2017 Crossing appears to be in good condition. Pipe has been selected to be internally cleaned and inspected as part of the DMP project. (DWR Sutter Yard- AFreitag)11/16/2016 Crossing appears to be in good condition. (DWR Sutter Yard- AFreitag)4/28/2016 Crossing appears to be in good condition.7/14/2015 Crossing appears in good condition. No noticeable issues to report.5/21/2014 Same as last inspection.12/2/2013 Same as last inspection.7/10/2013 Same as last inspection.4/17/2012 Drain is still in use. 4 inch pipe in channel near WS headwall (see photo). The pipe does not appear to impact the crossing. FIELD_STRUCT_DESC: 24-inch corrugated metal drainage pipe through the levee, 8.6 feet below the crown. Concrete "U" headwalls on both the waterside (WS) and landside (LS). Flap gate on the WS end. [Additional Reference(s): DWR Levee Log, 1993. USACE Sacramento O&M Manual 519, June 1962 (HLM 1.15)] FS Date: 6/16/2017 10:11:43 AM

Overview of levee crown at crossing looking D/S .

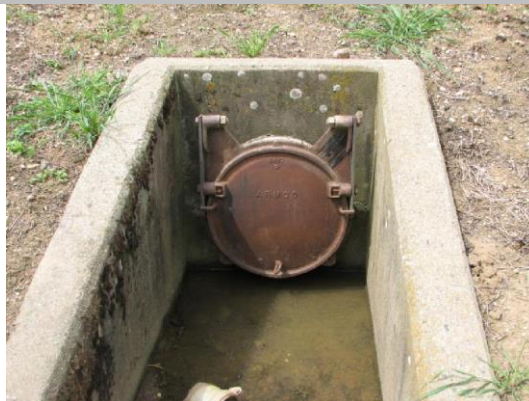
Photo 2 of 3 : UCIP_SP_2018_52180_66688.jpg

FS_ID:52180
DS_ID:16343
EP_NO: N/A
Repair Type: No Action Needed
Crossing Status: Found
UCIP Comments: 6/14/2017 Crossing appears to be in good condition. Pipe has been selected to be internally cleaned and inspected as part of the DMP project. (DWR Sutter Yard- AFreitag)11/16/2016 Crossing appears to be in good condition. (DWR Sutter Yard- AFreitag)4/28/2016 Crossing appears to be in good condition. 7/14/2015 Crossing appears in good condition. No noticeable issues to report. 5/21/2014 Same as last inspection. 12/2/2013 Same as last inspection. 7/10/2013 Same as last inspection. 4/17/2012 Drain is still in use. 4 inch pipe in channel near WS headwall (see photo). The pipe does not appear to impact the crossing.
FIELD_STRUCT_DESC: 24-inch corrugated metal drainage pipe through the levee, 8.6 feet below the crown. Concrete "U" headwalls on both the waterside (WS) and landside (LS). Flap gate on the WS end.

View of WS headwall and flap gate.

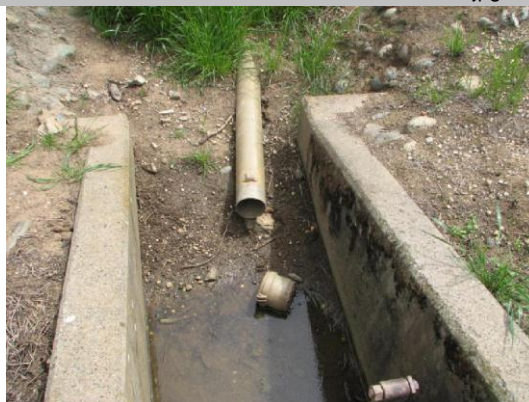
Photo 3 of 3 : UCIP_SP_2018_52180_66687.jpg

View of WS with pipe in channel.

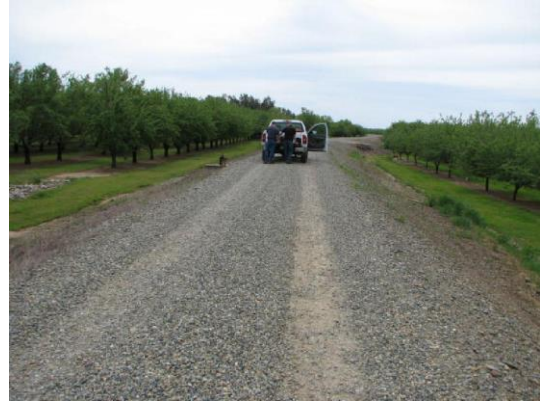
Photo 1 of 3 : UCIP_SP_2018_52182_66695.jpg

FS_ID:52182
DS_ID:16831
EP_NO: N/A
Repair Type: Urgent
Crossing Status: Found
UCIP Comments: 6/14/2017 Still no sign of WS pipe end. Pipe may need to be traced with GPR and excavated to determine if the WS end was properly capped after the Headwall and pipe sections were removed. Pipe has been selected to be internally cleaned and inspected as part of the DMP project. (DWR Sutter Yard - AFreitag)11/16/2016 WS structures still removed. (DWR Sutter Yard - AFreitag)10/17/2016 Landowner removed WS concrete headwall and pipe section through floodway to make room for orchard. The area disturbed appears to be from WS toe to where the mature trees are located within floodway, approximately 45 feet from WS toe. Crossing is classified as Urgent with potential levee integrity issues due to the disturbance of the WS without prior approval from the CVFPB. (DWR UCIP - omagana)
4/28/2016 Landowner appears to have removed the WS headwall and pipe to make room for planting more orchard trees. LS pipe end was full of water as it has no where to drain to anymore. Changing to urgent listing but it currently does not affect the levee integrity. (see photos 8, 9, & 10) (DWR Sutter Yard - afreitag)7/14/2015 Crossing appears in good condition. No noticeable issues to report. (DWR Sutter Yard - afreitag)5/21/2014 Same as last inspection. (DWR Sutter Yard - afreitag)12/2/2013 Pipe section was dug up and repaired. Crossing is now in good condition. (DWR Sutter Yard - afreitag) 4/17/2012 Pipe collapse on WS 10 feet from toe, needs repair. From WS, sediment is visible inside pipe. (DWR UCIP - omagana)

FIELD_STRUCT_DESC: 36-inch corrugated metal drainage pipe through the levee, 7.8 feet below the crown. Concrete "U" headwalls on both waterside (WS) and landside (LS) ends. Slide gate in corrugated metal pipe (CMP) riser on the WS slope. [Additional Reference(s): DWR Levee Log, 1993. USACE Sacramento O&M Manual 519, June 1962 (HLM 1.62)]
FS Date: 6/16/2017 10:21:08 AM

Overview of levee crown at crossing looking downstream.

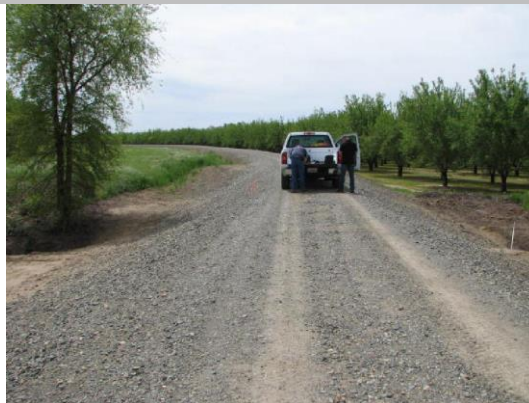
Photo 1 of 3 : UCIP_SP_2018_52185_66715.jpg

FS_ID:52185
DS_ID:16347
EP_NO: N/A
Repair Type: No Action Needed
Crossing Status: Found
UCIP Comments: 6/14/2017 Crossing appears to be in good condition.
(DWR Sutter Yard- AFreitag)11/16/2016 Crossing appears to be in good condition. (DWR Sutter Yard- AFreitag)4/28/2016 Crossing appears to be in good condition.7/14/2015 Crossing appears in good condition. No noticeable issues to report.5/21/2014 Same as last inspection.12/2/2013 Same as last inspection.7/15/2013 Same as last inspection.4/17/2012 Vegetation/sedimentation from WS has been removed. This crossing was listed in the USACE Periodic Inspection report as Corp's inspect
ID#USACE_CESPK_M13D_2011_p_0130 for WS flap gate closed and blocked by sediment.
FIELD_STRUCT_DESC: 24-inch corrugated metal drainage pipe through the levee, 9.4 feet below the crown. Concrete "U" headwall on both waterside (WS) and landside (LS) ends. Flap gate on the WS end. [Additional Reference(s): DWR Levee Log, 1993. USACE Sacramento O&M Manual 519, June 1962 (HLM 2.74)]

Overview of levee crown looking downstream at crossing.

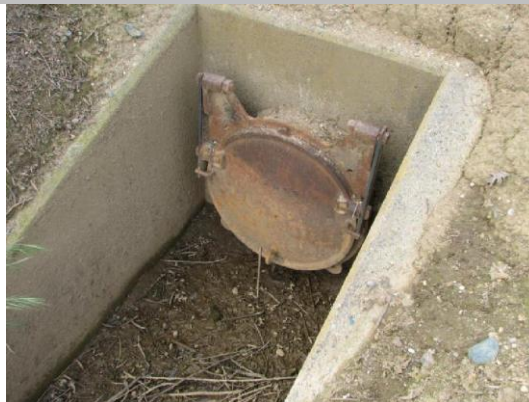
Photo 2 of 3 : UCIP_SP_2018_52185_66714.jpg

Flap gate at WS.

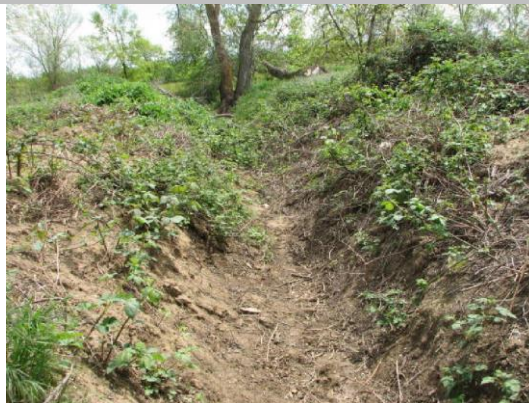
Photo 3 of 3 : UCIP_SP_2018_52185_66711.jpg

View of channel.

FS_ID:52185
DS_ID:16347
EP_NO: N/A
Repair Type: No Action Needed
Crossing Status: Found
UCIP Comments: 6/14/2017 Crossing appears to be in good condition.
(DWR Sutter Yard- AFreitag)11/16/2016 Crossing appears to be in good condition. (DWR Sutter Yard- AFreitag)4/28/2016 Crossing appears to be in good condition.7/14/2015 Crossing appears in good condition. No noticeable issues to report.5/21/2014 Same as last inspection.12/2/2013 Same as last inspection.7/15/2013 Same as last inspection.4/17/2012 Vegetation/sedimentation from WS has been removed. This crossing was listed in the USACE Periodic Inspection report as Corp's inspect
ID#USACE_CESPK_M13D_2011_p_0130 for WS flap gate closed and blocked by sediment.
FIELD_STRUCT_DESC: 24-inch corrugated metal drainage pipe through the levee, 9.4 feet below the crown. Concrete "U" headwall on both waterside (WS) and landside (LS) ends. Flap gate on the WS end. [Additional Reference(s): DWR Levee Log, 1993. USACE Sacramento O&M Manual 519, June 1962 (HLM 2.74)]

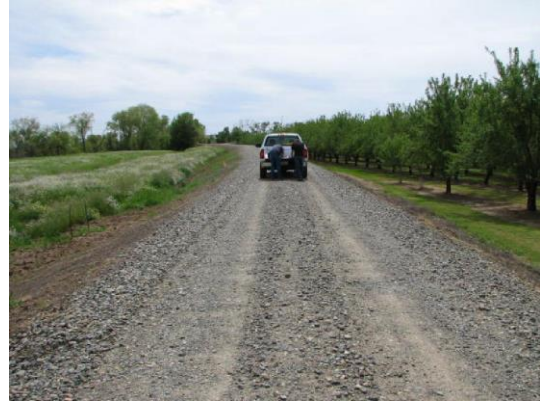
Photo 1 of 3 : UCIP_SP_2018_52186_66718.jpg

Comment Code						
Inspector Comment						
FS_ID:52186 DS_ID:17372 EP_NO: N/A Repair Type: Non-Urgent Crossing Status: Found UCIP Comments: 6/14/2017 WS flap gate is completely buried by sediment- needs to be dug out. Pipe is about 50% full of sediment inside. Pipe has been selected to be internally cleaned and inspected as part of the DMP project. (DWR Sutter Yard- AFreitag)11/16/2016 Pipe about 50% full of sediment. (DWR Sutter Yard- AFreitag)4/28/2016 Pipe on LS is about 50% full of sediment. There is now a concrete pipe that discharges into the LS inlet of this crossing. Not sure where the concrete pipe comes from.7/14/2015 Crossing appears in good condition. No noticeable issues to report.5/21/2014 Same as last inspection.12/2/2013 Pipe section was dug up and repaired. Crossing is now in good condition.7/15/2013 Pipe appears to have a possible hole in top of pipe about 10ft. in from LS headwall.4/17/2012 LS headwall blocked by sediment (50 % of opening is covered). LS floor is higher than LS pipe invert. WS headwall has been recently cleared of vegetation and sediment. This crossing was listed in the USACE Periodic Inspection report as Corp's inspect ID#USACE_CESPK_M13D_2011_p_0157 for WS and LS inlet/outlet blocked by sediment. FIELD_STRUCT_DESC: 36-inch corrugated metal drainage pipe through the levee, 11.8 feet below the crown. Flap gate is located on the waterside (WS). Concrete headwall located on the landside (LS). [Additional Reference(s): USACE Sacramento O&M Manual 519, June 1962 (HLM 3.10)] FS Date: 6/16/2017 12:28:31 PM

Overview of levee crown looking downstream at crossing.

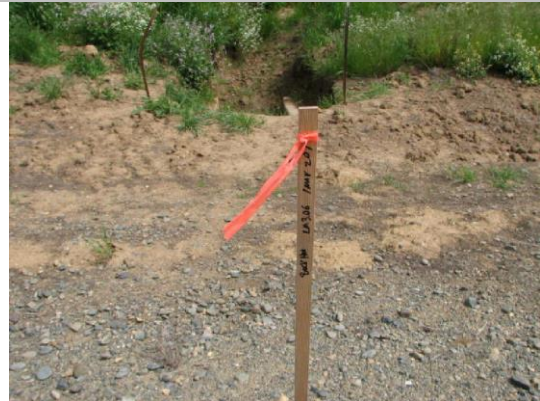
Photo 2 of 3 : UCIP_SP_2018_52186_66716.jpg

FS_ID:52186
DS_ID:17372
EP_NO: N/A
Repair Type: Non-Urgent
Crossing Status: Found
UCIP Comments: 6/14/2017 WS flap gate is completely buried by sediment- needs to be dug out. Pipe is about 50% full of sediment inside. Pipe has been selected to be internally cleaned and inspected as part of the DMP project. (DWR Sutter Yard- AFreitag)11/16/2016 Pipe about 50% full of sediment. (DWR Sutter Yard- AFreitag)4/28/2016 Pipe on LS is about 50% full of sediment. There is now a concrete pipe that discharges into the LS inlet of this crossing. Not sure where the concrete pipe comes from.7/14/2015 Crossing appears in good condition. No noticeable issues to report.5/21/2014 Same as last inspection.12/2/2013 Pipe section was dug up and repaired. Crossing is now in good condition.7/15/2013 Pipe appears to have a possible hole in top of pipe about 10ft. in from LS headwall.4/17/2012 LS headwall blocked by sediment (50 % of opening is covered). LS floor is higher than LS pipe invert. WS headwall has been recently cleared of vegetation and sediment. This crossing was listed in the USACE Periodic Inspection report as Corp's inspect ID#USACE_CESPK_M13D_2011_p_0157 for WS and LS inlet/outlet blocked by sediment.

WS levee slope.

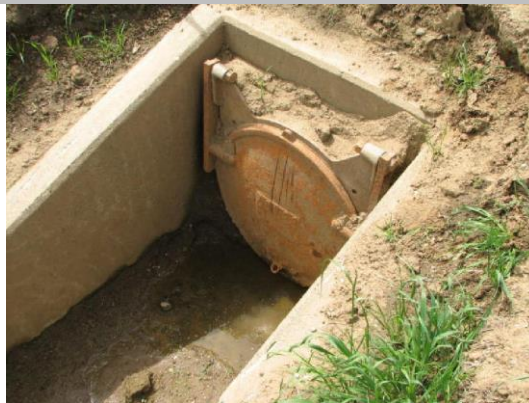
Photo 3 of 3 : UCIP_SP_2018_52186_66720.jpg

FS_ID:52186
DS_ID:17372
EP_NO: N/A
Repair Type: Non-Urgent
Crossing Status: Found
UCIP Comments: 6/14/2017 WS flap gate is completely buried by sediment- needs to be dug out. Pipe is about 50% full of sediment inside. Pipe has been selected to be internally cleaned and inspected as part of the DMP project. (DWR Sutter Yard- AFreitag)11/16/2016 Pipe about 50% full of sediment. (DWR Sutter Yard- AFreitag)4/28/2016 Pipe on LS is about 50% full of sediment. There is now a concrete pipe that discharges into the LS inlet of this crossing. Not sure where the concrete pipe comes from.7/14/2015 Crossing appears in good condition. No noticeable issues to report.5/21/2014 Same as last inspection.12/2/2013 Pipe section was dug up and repaired. Crossing is now in good condition.7/15/2013 Pipe appears to have a possible hole in top of pipe about 10ft. in from LS headwall.4/17/2012 LS headwall blocked by sediment (50 % of opening is covered). LS floor is higher than LS pipe invert. WS headwall has been recently cleared of vegetation and sediment. This crossing was listed in the USACE Periodic Inspection report as Corp's inspect ID#USACE_CESPK_M13D_2011_p_0157 for WS and LS inlet/outlet blocked by sediment.

Flap gate on waterside.

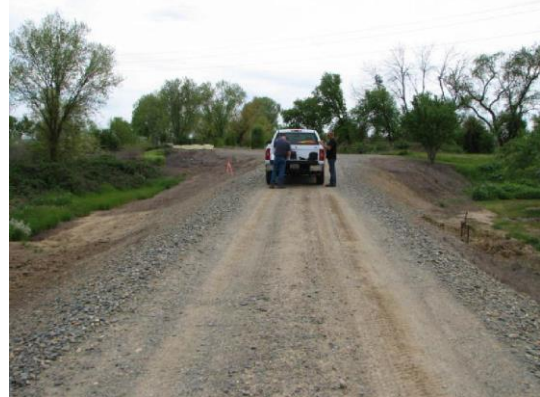
Photo 1 of 3 : UCIP_SP_2018_52188_66725.jpg

FS_ID:52188
DS_ID:16349
EP_NO: N/A
Repair Type: Non-Urgent
Crossing Status: Found
UCIP Comments: 6/14/2017 Both pipe ends and gates are mostly buried- need to be dug out. Pipe has been selected to be internally cleaned and inspected as part of the DMP project. (DWR Sutter Yard- A/Freitag)11/16/2016 Both gates closed but partially buried and unable to open. (DWR Sutter Yard- A/Freitag)4/28/2016 Sediment build up on both gates blocking them from operating properly.7/14/2015 Crossing appears in good condition. No noticeable issues to report.5/21/2014 Same as last inspection.12/2/2013 Same as last inspection.7/15/2013 Stem on LS screw gate has been replaced and is now full functional.4/17/2012 LS slide gate stem is bent and prevents gate from fully closing. Both WS and LS have been cleared of debris and sediment. This crossing was listed in the USACE Periodic Inspection report as Corp's inspect ID#USACE_CESPK_M13D_2011_p_0162 for inoperable gates on WS & LS due to sediment and grass blocking inlet and outlet.

Overview of levee crown looking DS at crossing.

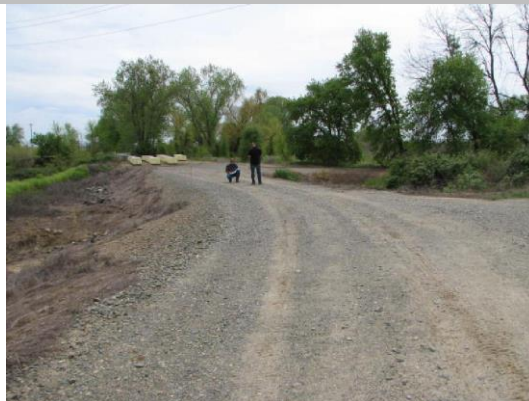
Photo 1 of 3 : UCIP_SP_2018_52189_66731.jpg

FS_ID:52189
DS_ID:16350
EP_NO: N/A
Repair Type: No Action Needed
Crossing Status: Found
UCIP Comments: 6/14/2017 WS flapgate is buried by sediment- needs to be dug out. Pipe has been selected to be internally cleaned and inspected as part of the DMP project. (DWR Sutter Yard- AFreitag)11/16/2016 Crossing appears to be in good condition. (DWR Sutter Yard- AFreitag)4/28/2016 Crossing appears to be in good condition.7/14/2015 Crossing appears in good condition. No noticeable issues to report.5/21/2014 Same as last inspection.12/2/2013 Same as last inspection.7/15/2013 Same as last inspection.4/17/2012 WS headwall has been cleared of debris and sedimentation.
FIELD_STRUCT_DESC: 24-inch corrugated metal drainage pipe through the levee, 8.4 feet below the crown. Concrete "U" headwalls on both the waterside (WS) and landside (LS) ends. Flap gate on the WS end. [Additional Reference(s): DWR Levee Log, 1993. USACE Sacramento O&M Manual 519, June 1962 (HLM 3.31)]

Overview of levee crown at crossing.

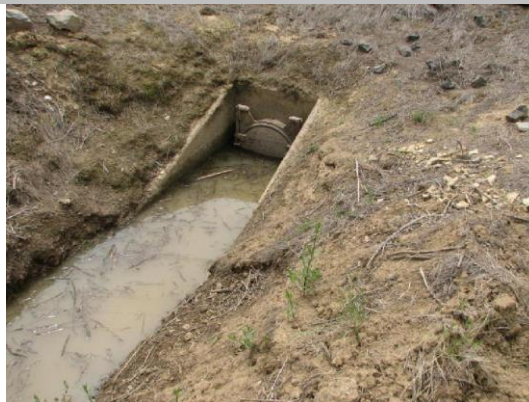
Photo 2 of 3 : UCIP_SP_2018_52189_66730.jpg

View of WS flap gate.

Item	DWR UCIP LMA Responsibility			39.553129 °	39.553129 °	
				-121.706640 °	-121.706640 °	
DWR ID						
Comment Code						
Inspector Comment						
FS_ID:52189 DS_ID:16350 EP_NO: N/A Repair Type: No Action Needed Crossing Status: Found UCIP Comments: 6/14/2017 WS flapgate is buried by sediment- needs to be dug out. Pipe has been selected to be internally cleaned and inspected as part of the DMP project. (DWR Sutter Yard- A/Freitag)11/16/2016 Crossing appears to be in good condition. (DWR Sutter Yard- A/Freitag)4/28/2016 Crossing appears to be in good condition.7/14/2015 Crossing appears in good condition. No noticeable issues to report.5/21/2014 Same as last inspection.12/2/2013 Same as last inspection.7/15/2013 Same as last inspection.4/17/2012 WS headwall has been cleared of debris and sedimentation. FIELD_STRUCT_DESC: 24-inch corrugated metal drainage pipe through the levee, 8.4 feet below the crown. Concrete "U" headwalls on both the waterside (WS) and landside (LS) ends. Flap gate on the WS end. [Additional Reference(s): DWR Levee Log, 1993. USACE Sacramento O&M Manual 519, June 1962 (HLM 3.31)] FS Date: 6/16/2017 12:32:19 PM

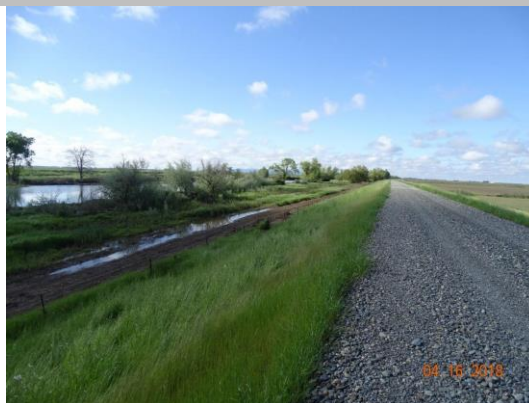
Photo 1 of 1 : SP_2018_MA0013_300_76_20180425_00145.jpg

LM Start	3.71	Rating **	M	Issue No.	76
LM End	18.50	Issue Type +	Ma	Location *	WS
Category	Earthen Levee			GPS Latitude/Longitude	
				Start	End
Item	Vegetation			39.546738 °	39.373430 °
				-121.707600 °	-121.850527 °
DWR ID	DWR_MA0013_01_s_2018_76				
Comment Code					
V1 : Control annual grass and weeds on the levee slopes and easements.					
Inspector Comment					
Remove the native vegetation from the waterside slope.

View of the native grasses along the waterside slope.

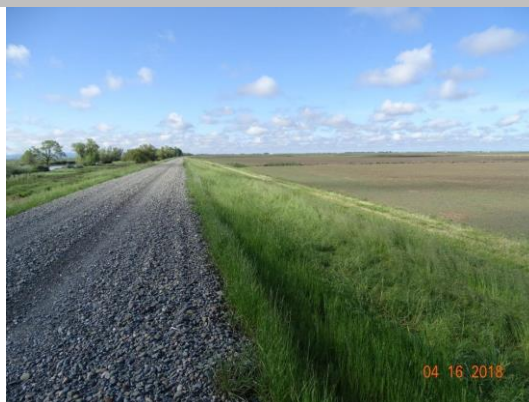
Photo 1 of 1 : SP_2018_MA0013_300_77_20180425_00146.jpg

LM Start	3.71	Rating **	M	Issue No.	77
LM End	15.75	Issue Type +	Ma	Location *	LS
Category	Earthen Levee			GPS Latitude/Longitude	
				Start	End
Item	Vegetation			39.546727 °	39.398780 °
				-121.707600 °	-121.810932 °
DWR ID	DWR_MA0013_01_s_2018_77				
Comment Code					
V1 : Control annual grass and weeds on the levee slopes and easements.					
Inspector Comment					
Remove the native vegetation from the landside slope.

View of the native vegetation along the landside slope.

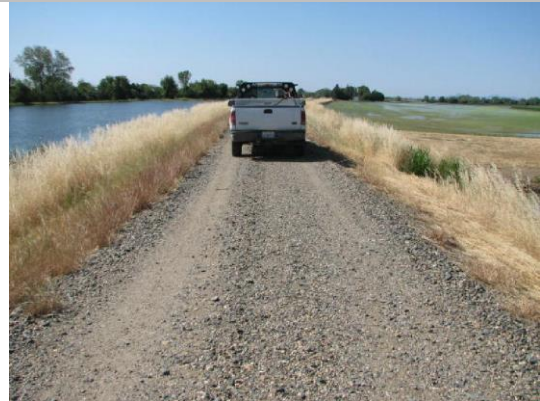
Photo 1 of 3 : UCIP_SP_2018_52190_66736.jpg

FS_ID:52190
DS_ID:16351
EP_NO: N/A
Repair Type: No Action Needed
Crossing Status: Found
UCIP Comments: 6/14/2017 Both pipe ends were underwater during site visit. Pipe has been selected to be internally cleaned and inspected as part of the DMP project. (DWR Sutter Yard- A Freitag)11/16/2016 Crossing appears to be in good condition. (DWR Sutter Yard- A Freitag)4/28/2016 Both sides of the crossing were underwater during time of inspection.7/14/2015 Crossing appears in good condition. No noticeable issues to report.5/21/2014 Same as last inspection.12/2/2013 Same as last inspection.7/15/2013 Slopes have been cleared of vegetation and are in good condition.4/18/2012 Limited inspection on WS and LS slope due to dense vegetation. Need photos of cleared slopes.
FIELD_STRUCT_DESC: 24-inch corrugate metal drainage pipe through the levee, 8.1 feet below the crown. Flap gate on the waterside (WS) end. Slide gate located on the landside (LS) end. Concrete "U" headwalls on both ends. [Additional Reference(s): DWR Levee Log, 1993. USACE Sacramento O&M Manual 519, June 1962 (HLM 3.80)]

Overview of levee crown at crossing looking downstream.

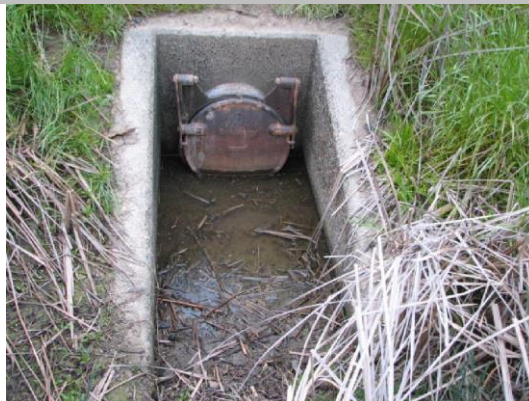
Photo 3 of 3 : UCIP_SP_2018_52190_66735.jpg

WS flap gate

Comment Code					
Inspector Comment					
FS_ID:52190 DS_ID:16351 EP_NO: N/A Repair Type: No Action Needed Crossing Status: Found UCIP Comments: 6/14/2017 Both pipe ends were underwater during site visit. Pipe has been selected to be internally cleaned and inspected as part of the DMP project. (DWR Sutter Yard- A Freitag)11/16/2016 Crossing appears to be in good condition. (DWR Sutter Yard- A Freitag)4/28/2016 Both sides of the crossing were underwater during time of inspection.7/14/2015 Crossing appears in good condition. No noticeable issues to report.5/21/2014 Same as last inspection.12/2/2013 Same as last inspection.7/15/2013 Slopes have been cleared of vegetation and are in good condition.4/18/2012 Limited inspection on WS and LS slope due to dense vegetation. Need photos of cleared slopes. FIELD_STRUCT_DESC: 24-inch corrugate metal drainage pipe through the levee, 8.1 feet below the crown. Flap gate on the waterside (WS) end. Slide gate located on the landside (LS) end. Concrete "U" headwalls on both ends. [Additional Reference(s): DWR Levee Log, 1993. USACE Sacramento O&M Manual 519, June 1962 (HLM 3.80)] FS Date: 6/16/2017 12:33:16 PM

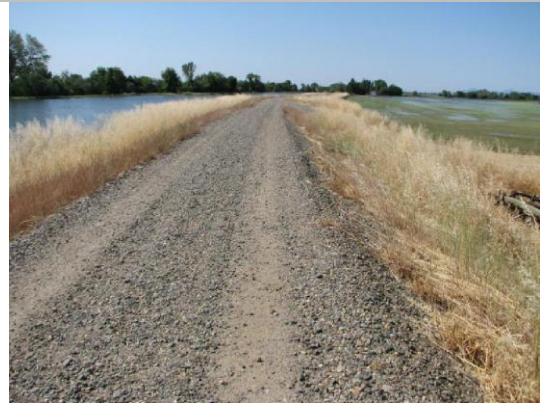
Photo 1 of 3 : UCIP_SP_2018_52191_66743.jpg

FS_ID:52191
DS_ID:16365
EP_NO: N/A
Repair Type: Non-Urgent
Crossing Status: Found
UCIP Comments: 6/14/2017 Appears abandoned- needs to be done properly. WS gate was buried/submerged and the LS slide gate is still damaged and buried. Pipe has been selected to be internally cleaned and inspected as part of the DMP project. (DWR Sutter Yard- A Freitag) 11/16/2016 Both LS and WS gates buried. (DWR Sutter Yard- A Freitag) 4/28/2016 Abandoned crossing. LS screw is still bent and mostly buried. 7/14/2015 LS screw gate is still damaged and buried. Crossing is non-functional. 5/21/2014 Same as last inspection. 12/2/2013 Same as last inspection. 7/15/2013 Slopes have been cleared of vegetation and are in good condition. LS screw gate is still bent and silted over. 4/18/2012 LS slide gate covered with silt. Slide gate is bent. Crossing appears not be in use. Limited inspection on WS and LS slope due to dense vegetation. Need photos of cleared slopes.

Overview of levee crown at crossing looking downstream.

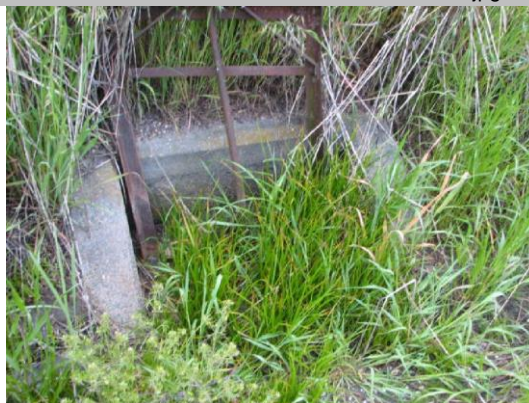
Photo 3 of 3 : UCIP_SP_2018_52191_66742.jpg

LS slide gate covered with silt. Slide gate is bent.

Comment Code					
Inspector Comment					
<p>FS_ID:52191 DS_ID:16365 EP_NO: N/A Repair Type: Non-Urgent Crossing Status: Found UCIP Comments: 6/14/2017 Appears abandoned- needs to be done properly. WS gate was buried/submerged and the LS slide gate is still damaged and buried. Pipe has been selected to be internally cleaned and inspected as part of the DMP project. (DWR Sutter Yard- A/Freitag)11/16/2016 Both LS and WS gates buried. (DWR Sutter Yard- A/Freitag)4/28/2016 Abandoned crossing. Ls screw is still bent and mostly buried.7/14/2015 LS screw gate is still damaged and buried. Crossing is non-functional.5/21/2014 Same as last inspection.12/2/2013 Same as last inspection.7/15/2013 Slopes have been cleared of vegetation and are in good condition. LS screw gate is still bent and silted over.4/18/2012 LS slide gate covered with silt. Slide gate is bent. Crossing appears not be in use. Limited inspection on WS and LS slope due to dense vegetation. Need photos of cleared slopes. FIELD_STRUCT_DESC: *ABANDONED* 24-inch corrugated metal drainage pipe through the levee, 7.9 feet below the crown. Flap gate on the waterside (WS) end. Screw gate on the landside (LS) end. Concrete "U" headwalls on both ends. [Additional Reference(s): DWR Levee Log, 1993. USACE Sacramento O&M Manual 519, June 1962 (HLM 3.82)] FS Date: 6/16/2017 12:35:50 PM</p>

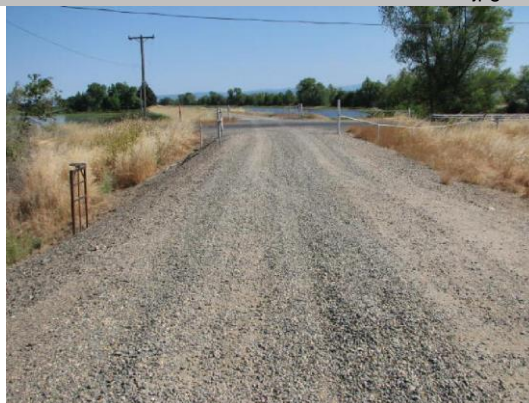
Photo 1 of 3 : UCIP_SP_2018_52193_66752.jpg

Overview of levee crown at crossing looking upstream.

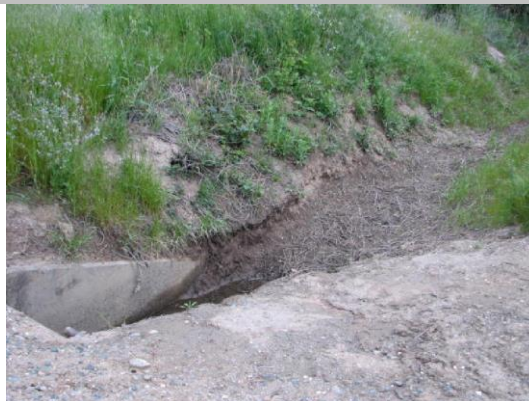
Photo 3 of 3 : UCIP_SP_2018_52193_66750.jpg

View of WS.

Comment Code					
Inspector Comment					
FS_ID:52193 DS_ID:16341 EP_NO: N/A Repair Type: No Action Needed Crossing Status: Found UCIP Comments: 6/14/2017 WS flapgate is shut but blocked by sediment- needs to be dug out. LS slide gate has some minor sediment built up against it. Pipe has been selected to be internally cleaned and inspected as part of the DMP project. (DWR Sutter Yard- A/Freitag)11/16/2016 Crossing appears to be in good condition. (DWR Sutter Yard- A/Freitag)4/28/2016 Crossing appears to be in good condition.7/13/2015 Crossing appears in good condition. No noticeable issues to report.5/21/2014 Same as last inspection.12/2/2013 Same as last inspection.7/15/2013 Same as last inspection.4/18/2012 Minor debris on landside inlet. This crossing was listed in the USACE Periodic Inspection report as Corp's inspect ID#USACE_CESPK_M13D_2011_p_0189 for sediment and grass blocking WS and LS. FIELD_STRUCT_DESC: 36-inch corrugated metal drainage pipe through the levee, 9.1 feet below the crown. Flap gate on the waterside (WS) end. Slide gate located on the landside (LS) end. Concrete "U" headwalls on both ends. [Additional Reference(s): DWR Levee Log, 1993. USACE Sacramento O&M Manual 519, June 1962 (HLM 4.43)] FS Date: 6/16/2017 12:52:19 PM

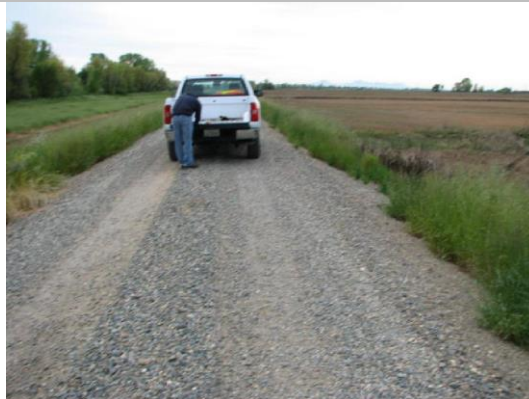
Photo 1 of 3 : UCIP_SP_2018_52194_66756.jpg

Overview of levee crown at crossing looking downstream at right bank of Cherokee Canal.

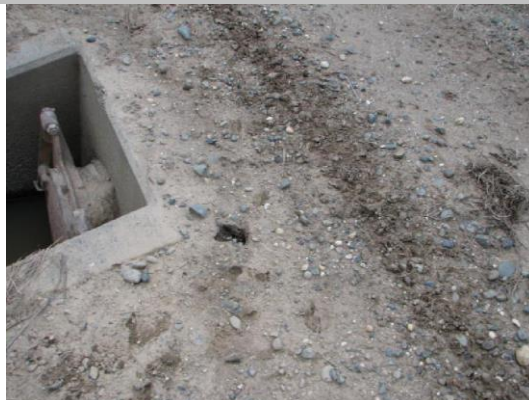
Photo 2 of 3 : UCIP_SP_2018_52194_66758.jpg

Burrow activity on WS slope.

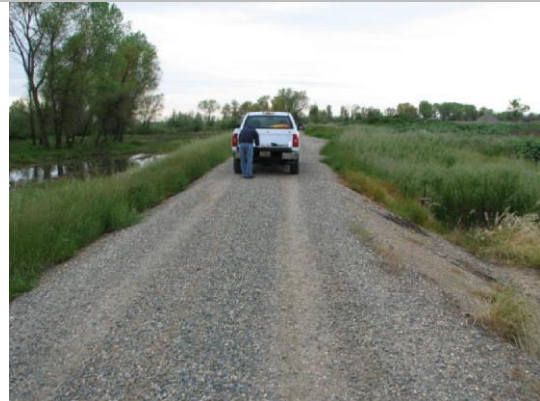
Photo 1 of 3 : UCIP_SP_2018_52195_66762.jpg

Overview of levee crown at crossing looking D/S on right bank of Cherokee Canal.

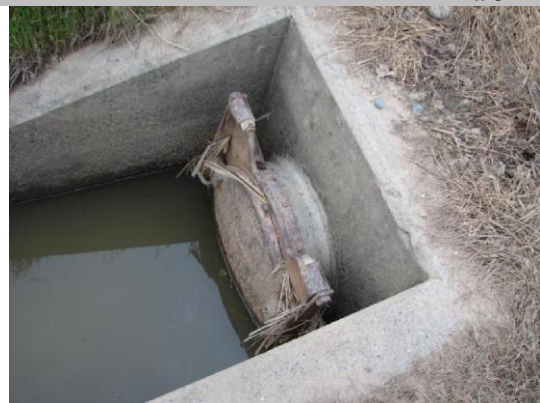
Photo 2 of 3 : UCIP_SP_2018_52195_66760.jpg

WS Flap Gate

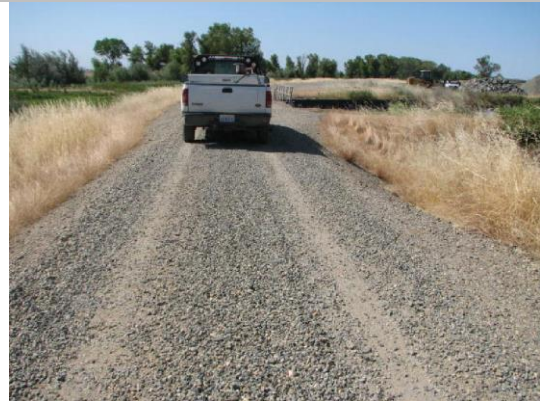
Photo 1 of 3 : UCIP_SP_2018_52196_66764.jpg

Overview of levee crown at crossing looking downstream.

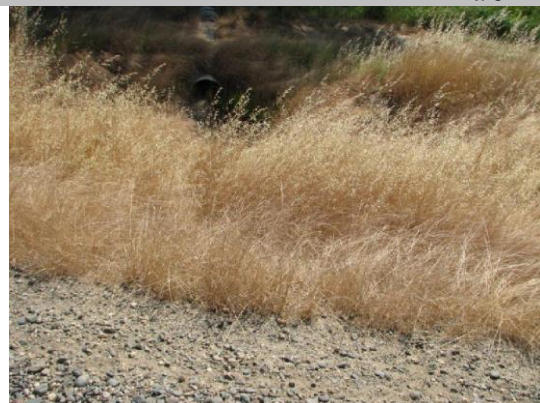
Photo 2 of 3 : UCIP_SP_2018_52196_66765.jpg

View of WS slope and channel.

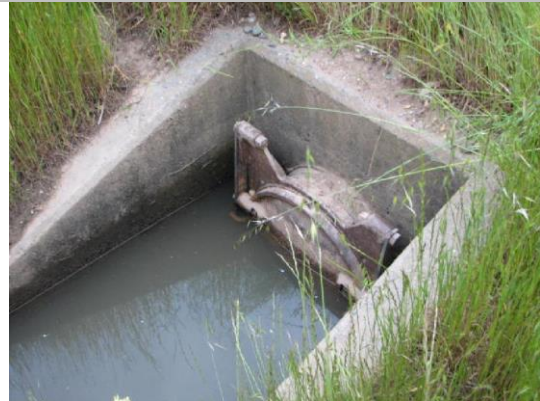
Photo 3 of 3 : UCIP_SP_2018_52196_66768.jpg

View of WS flap gate.

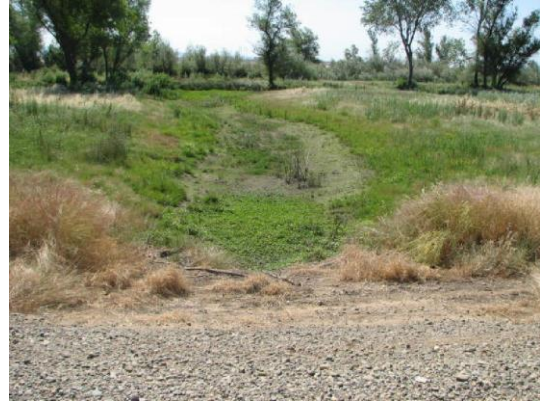
Photo 2 of 3 : UCIP_SP_2018_52201_66794.jpg

Comment Code						
Inspector Comment						
FS_ID:52201 DS_ID:16359 EP_NO: N/A Repair Type: Non-Urgent Crossing Status: Found UCIP Comments: 6/14/2017 WS Flap gate is completely buried- needs to be dug out. LS is blocked off by flashboards that are partially buried. Pipe has been selected to be internally cleaned and inspected as part of the DMP project. (DWR Sutter Yard- A Freitag)11/16/2016 WS still completely buried. (DWR Sutter Yard- A Freitag)4/28/2016 WS gate and headwall are buried. Only the top of the headwall was visible. LS appeared ok.7/13/2015 Both the LS screw gate and WS flapgate are completely buried.5/21/2014 Same as last inspection.12/2/2013 Same as last inspection.7/15/2013 Slopes have been cleared of vegetation and are in good condition. WS headwall and flapgate are fully covered in debris and not visible. Need to clear.4/18/2012 High sedimentation build up at WS and LS headwall. Limited inspection due to dense vegetation on WS and LS slope. Need photo of cleared WS and LS slopes. This crossing was listed in the USACE Periodic Inspection report as Corp's inspect ID# USACE_CESPK_M13D_2011_p_0210 for WS gate submerged. FIELD_STRUCT_DESC: 24-inch corrugated metal drainage pipe through the levee, 9.2 feet below the crown. Flap gate on the waterside (WS) end. Concrete "U" headwalls on both ends. [Additional Reference(s): DWR Levee Log, 1993. USACE Sacramento O&M Manual 519, June 1962 (HLM 5.73)] FS Date: 6/16/2017 1:29:37 PM

View of WS slope and toe.

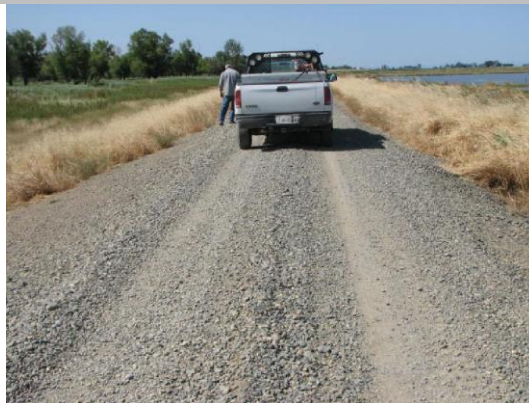
Photo 1 of 3 : UCIP_SP_2018_52202_66800.jpg

FS_ID:52202
DS_ID:16360
EP_NO: N/A
Repair Type: No Action Needed
Crossing Status: Found
UCIP Comments: 6/14/2017 Crossing appears to be in good condition. LS is completely submerged in an irrigation ditch. Pipe has been selected to be internally cleaned and inspected as part of the DMP project. (DWR Sutter Yard- AFreitag)11/16/2016 Crossing appears to be in good condition. (DWR Sutter Yard- AFreitag)4/28/2016 Crossing appears to be in good condition.7/13/2015 LS screw gate was completely submerged but crossing appears to be in good condition.5/21/2014 Same as last inspection.12/2/2013 Same as last inspection.7/15/2013 Same as last inspection.4/18/2012 Burrow activity near crossing; burrow holes present on LS. FIELD_STRUCT_DESC: 24-inch corrugated metal drainage pipe through the levee, 6.2 feet below the crown. Flap gate on the waterside (WS) end. Slide gate on the landside (LS) end. Concrete "U" headwalls on both ends. [Additional Reference(s): DWR Levee Log, 1993. USACE Sacramento O&M Manual 519, June 1962 (HLM 5.97)]

Overview of levee crown at crossing looking downstream.

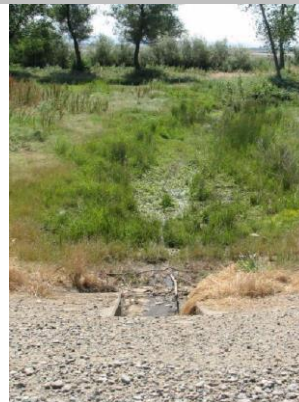
Photo 2 of 3 : UCIP_SP_2018_52202_66801.jpg

View of WS slope and toe.

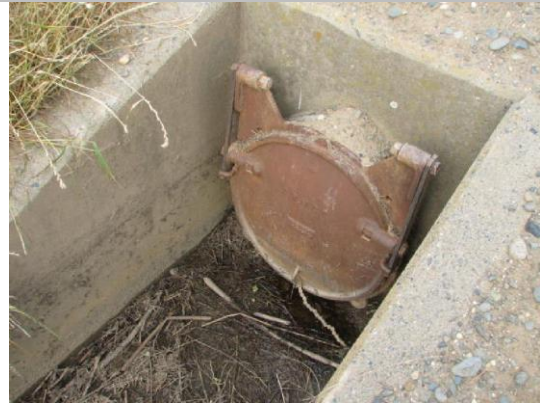
Photo 3 of 3 : UCIP_SP_2018_52202_66799.jpg

FS_ID:52202
DS_ID:16360
EP_NO: N/A
Repair Type: No Action Needed
Crossing Status: Found
UCIP Comments: 6/14/2017 Crossing appears to be in good condition. LS is completely submerged in an irrigation ditch. Pipe has been selected to be internally cleaned and inspected as part of the DMP project. (DWR Sutter Yard- AFreitag)11/16/2016 Crossing appears to be in good condition. (DWR Sutter Yard- AFreitag)4/28/2016 Crossing appears to be in good condition.7/13/2015 LS screw gate was completely submerged but crossing appears to be in good condition.5/21/2014 Same as last inspection.12/2/2013 Same as last inspection.7/15/2013 Same as last inspection.4/18/2012 Burrow activity near crossing; burrow holes present on LS.
FIELD_STRUCT_DESC: 24-inch corrugated metal drainage pipe through the levee, 6.2 feet below the crown. Flap gate on the waterside (WS) end. Slide gate on the landside (LS) end. Concrete "U" headwalls on both ends. [Additional Reference(s): DWR Levee Log, 1993. USACE Sacramento O&M Manual 519, June 1962 (HLM 5.97)]

Flap gate WS

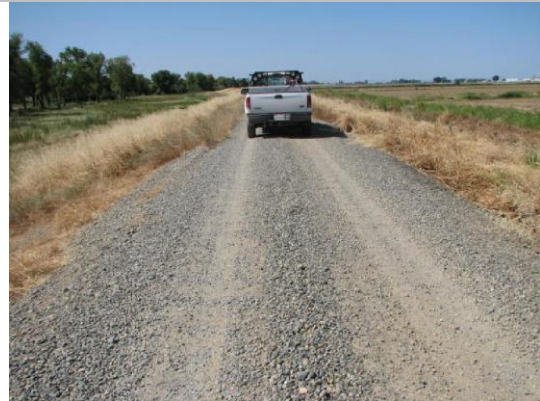
Photo 1 of 3 : UCIP_SP_2018_52203_66808.jpg

FS_ID:52203
DS_ID:16361
EP_NO: N/A
Repair Type: Non-Urgent
Crossing Status: Found
UCIP Comments: 6/14/2017 WS appears to be in good condition. LS slide gate is buried and submerged. Pipe has been selected to be internally cleaned and inspected as part of the DMP project. (DWR Sutter Yard- A/Freitag)11/16/2016 LS screwgate is buried and non-operational. (DWR Sutter Yard- A/Freitag)4/28/2016 LS screwgate is still completely buried. 7/13/2015 LS screw gate is completely buried.5/21/2014 Same as last inspection.7/15/2013 WS slope has been cleared of vegetation and is in good condition. LS screw gate is still buried.12/2/2013 Same as last inspection.4/18/2012 LS slide gate is buried. Pipe is not visible on LS toe. Limited inspection on WS slope due to dense vegetation.
FIELD_STRUCT_DESC: 24-inch corrugated metal drainage pipe through the levee, 7.4 feet below the crown. Flap gate on the waterside (WS) end. Slide gate on the landside (LS) end. Concrete "U" headwalls on both ends. [Additional Reference(s): DWR Levee Log, 1993. USACE Sacramento O&M Manual 519, June 1962 (HLM 6.34)]

Overview of levee crown at crossing looking downstream.

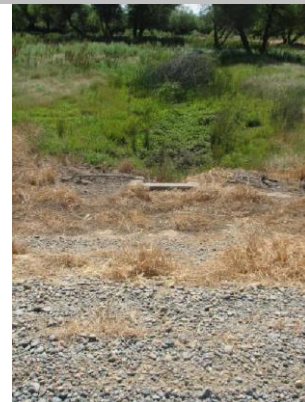
Photo 2 of 3 : UCIP_SP_2018_52203_66806.jpg

View of WS slope and toe.

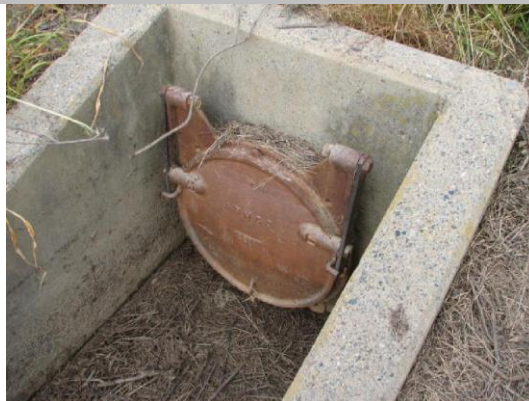
Photo 3 of 3 : UCIP_SP_2018_52203_66804.jpg

FS_ID:52203
DS_ID:16361
EP_NO: N/A
Repair Type: Non-Urgent
Crossing Status: Found
UCIP Comments: 6/14/2017 WS appears to be in good condition. LS slide gate is buried and submerged. Pipe has been selected to be internally cleaned and inspected as part of the DMP project. (DWR Sutter Yard- A Freitag) 11/16/2016 LS screwgate is buried and non-operational. (DWR Sutter Yard- A Freitag) 4/28/2016 LS screwgate is still completely buried. 7/13/2015 LS screw gate is completely buried. 5/21/2014 Same as last inspection. 7/15/2013 WS slope has been cleared of vegetation and is in good condition. LS screw gate is still buried. 12/2/2013 Same as last inspection. 4/18/2012 LS slide gate is buried. Pipe is not visible on LS toe. Limited inspection on WS slope due to dense vegetation.
FIELD_STRUCT_DESC: 24-inch corrugated metal drainage pipe through the levee, 7.4 feet below the crown. Flap gate on the waterside (WS) end. Slide gate on the landside (LS) end. Concrete "U" headwalls on both ends. [Additional Reference(s): DWR Levee Log, 1993. USACE Sacramento O&M Manual 519, June 1962 (HLM 6.34)]

View of WS flap gate.

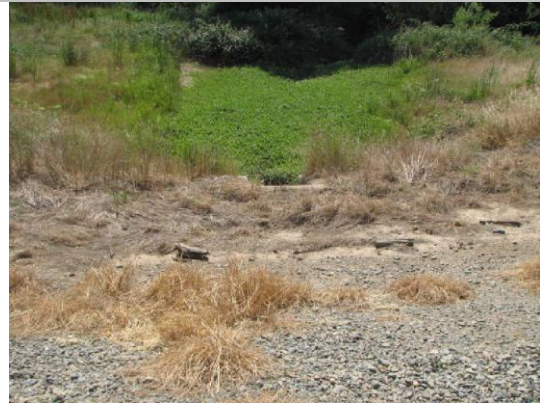
Photo 2 of 3 : UCIP_SP_2018_52204_66813.jpg

FS_ID:52204
DS_ID:16362
EP_NO: 5200B
Repair Type: No Action Needed
Crossing Status: Found
UCIP Comments: 6/14/2017 Hole/erosion behind the flashboards was repaired. New flash boards were installed and the erosion hole filled back in. Pipe has been selected to be internally cleaned and inspected as part of the DMP project. (DWR Sutter Yard- AFreitag)11/16/2016 Hole/erosion still present behind the LS flashboards. (DWR Sutter Yard- AFreitag)4/28/2016 Hole still present behind the LS flashboards. Rest of the crossing appeared in good condition. (DWR Sutter Yard - afreitag)7/13/2015 Hole still present behind the LS flashboards. (DWR Sutter Yard - afreitag)5/21/2014 Same as last inspection. (DWR Sutter Yard - afreitag)12/2/2013 Same as last inspection. (DWR Sutter Yard - afreitag)7/15/2013 WS slope has been cleared of vegetation and is in good condition. Hole is still present behind flash boards on LS. (DWR Sutter Yard - afreitag)4/18/2012 Hole behind flashboards against slide gate on LS slope (Health and Safety Issue). Limited inspection on WS slope due to dense vegetation. Need photo of cleared slope on WS. (DWR UCIP - omagana)

View of WS slope and toe.

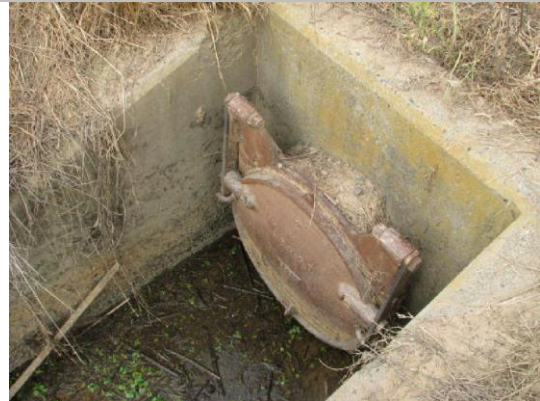
Photo 3 of 3 : UCIP_SP_2018_52204_66811.jpg

FS_ID:52204
DS_ID:16362
EP_NO: 5200B
Repair Type: No Action Needed
Crossing Status: Found
UCIP Comments: 6/14/2017 Hole/erosion behind the flashboards was repaired. New flash boards were installed and the erosion hole filled back in. Pipe has been selected to be internally cleaned and inspected as part of the DMP project. (DWR Sutter Yard- AFreitag)11/16/2016 Hole/erosion still present behind the LS flashboards. (DWR Sutter Yard- AFreitag)4/28/2016 Hole still present behind the LS flashboards. Rest of the crossing appeared in good condition. (DWR Sutter Yard - afreitag)7/13/2015 Hole still present behind the LS flashboards. (DWR Sutter Yard - afreitag)5/21/2014 Same as last inspection. (DWR Sutter Yard - afreitag)12/2/2013 Same as last inspection. (DWR Sutter Yard - afreitag)7/15/2013 WS slope has been cleared of vegetation and is in good condition. Hole is still present behind flash boards on LS. (DWR Sutter Yard - afreitag)4/18/2012 Hole behind flashboards against slide gate on LS slope (Health and Safety Issue). Limited inspection on WS slope due to dense vegetation. Need photo of cleared slope on WS. (DWR UCIP - omagana)

WS flap gate.

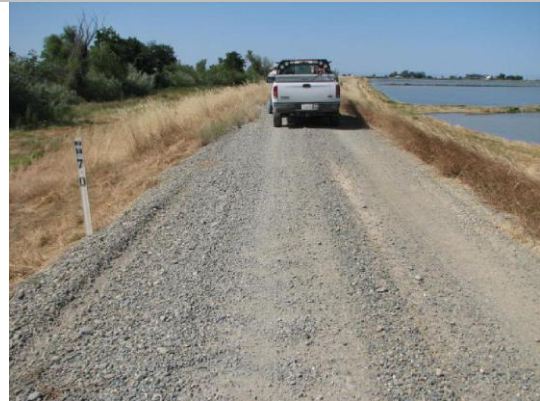
Photo 1 of 3 : UCIP_SP_2018_52211_66833.jpg

FS_ID:52211
DS_ID:16329
EP_NO: N/A
Repair Type: Non-Urgent
Crossing Status: Found
UCIP Comments: 6/14/2017 LS slide gate is still damaged and needing to be replaced. WS appeared to be in good condition. Pipe has been selected to be internally cleaned and inspected as part of the DMP project. (DWR Sutter Yard- AFreitag)11/16/2016 Needs a new screw gate installed on the LS. (DWR Sutter Yard- AFreitag)4/28/2016 LS slide gate is still bent. Everything else with the crossing appeared ok.7/13/2015 LS screw gate needs to be replaced. Everything else with crossing seems to be in good condition.5/21/2014 Same as last inspection.12/2/2013 Same as last inspection.7/15/2013 Slopes have been cleared of vegetation and are in good condition. There were no apparent signs of settling. LS screw gate is still damaged.4/18/2012 LMA's inspection sheet of 2011 indicates settlement and visible corrosion. Damage/severe corrosion on screw gate where it bolts to headwall. No visible signs of settlement due to high vegetation cover. Limited inspection on WS and LS slopes due to dense vegetation. Need photos of cleared slopes for this crossing. FIELD_STRUCT_DESC: 24-inch corrugated metal drainage pipe through the levee, 9.8 feet below the crown. Flap gate on the waterside (WS) end. Slide gate on the landside (LS) end. Concrete headwall on both ends. [Additional Reference(s): DWR Levee Log, 1993. USACE Sacramento O&M Manual 519, June 1962 (HLM 7.10)]

Overview of levee crown at crossing looking D/S.

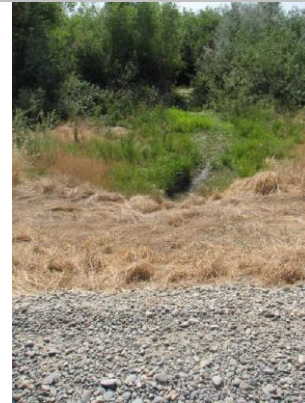
Photo 2 of 3 : UCIP_SP_2018_52211_66832.jpg

Comment Code						
Inspector Comment						
FS_ID:52211 DS_ID:16329 EP_NO: N/A Repair Type: Non-Urgent Crossing Status: Found UCIP Comments: 6/14/2017 LS slide gate is still damaged and needing to be replaced. WS appeared to be in good condition. Pipe has been selected to be internally cleaned and inspected as part of the DMP project. (DWR Sutter Yard- AFreitag)11/16/2016 Needs a new screw gate installed on the LS. (DWR Sutter Yard- AFreitag)4/28/2016 LS slide gate is still bent. Everyhting else with the crossing appeared ok.7/13/2015 LS screw gate needs to be replaced. Everything else with crossing seems to be in good condition.5/21/2014 Same as last inspection.12/2/2013 Same as last inspection.7/15/2013 Slopes have been cleared of vegetation and are in good condition. There were no apparent signs of settling. LS screw gate is still damaged.4/18/2012 LMA's inspection sheet of 2011 indicates settlement and visible corrosion. Damage/severe corrosion on screw gate where it bolts to headwall. No visible signs of settlement due to high vegetation cover. Limited inspection on WS and LS slopes due to dense vegetation. Need photos of cleared slopes for this crossing. FIELD_STRUCT_DESC: 24-inch corrugated metal drainage pipe through the levee, 9.8 feet below the crown. Flap gate on the waterside (WS) end. Slide gate on the landside (LS) end. Concrete headwall on both ends. [Additional Reference(s): DWR Levee Log, 1993. USACE Sacramento O&M Manual 519, June 1962 (HLM 7.10)] FS Date: 6/19/2017 10:17:38 AM

View of WS slope and toe.

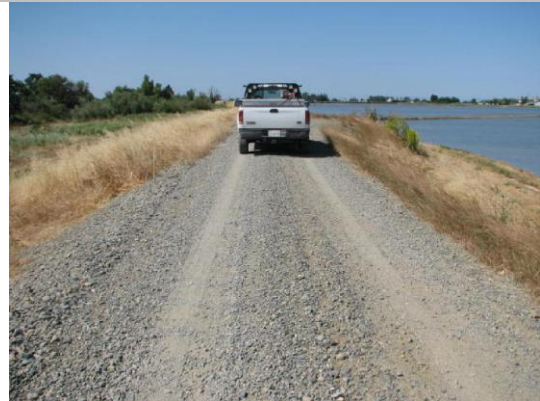
Photo 1 of 3 : UCIP_SP_2018_52212_66844.jpg

FS_ID:52212
DS_ID:16354
EP_NO: N/A
Repair Type: Non-Urgent
Crossing Status: Found
UCIP Comments: 6/14/2017 LS slide gate stem still bent. WS appeared to be in good condition. Pipe has been selected to be internally cleaned and inspected as part of the DMP project. (DWR Sutter Yard- A Freitag)11/16/2016 Screw gate stem bent but gate is still operational. (DWR Sutter Yard- A Freitag)4/28/2106 Tested positive closure device the bent stem on the slide gate did not seem to affect its functions. Gate operable.7/13/2015 LS screw gate stem is still bent. Gate should still be able to close fully. The rest of the crossing seems to be in good condition.5/21/2014 Same as last inspection.12/2/2013 Same as last inspection.7/15/2013 Slopes have been cleared of vegetation and are in good condition. LS screw gate stem is still bent.4/18/2012 LS slide gate stem is bent and needs to be replaced. Limited inspection on WS and LS slope due to dense vegetation. Need photos of cleared slopes during next inspection. Confirmed flap gate on WS. This crossing was listed in the USACE Periodic Inspection report as Corp's inspect ID#USACE_CESPK_M13D_2011_p_0244 for submerged WS gate. FIELD_STRUCT_DESC: 24-inch corrugated metal drainage pipe through the levee, 11.2 feet below the crown. Flap gate on the waterside (WS) end. Slide gate on the landside (LS) end. Concrete "U" headwall on both ends. [Additional Reference(s): DWR Levee Log, 1993. USACE Sacramento O&M Manual 519, June 1962 (HLM 7.34)]

Overview of levee crown at crossing looking D/S.

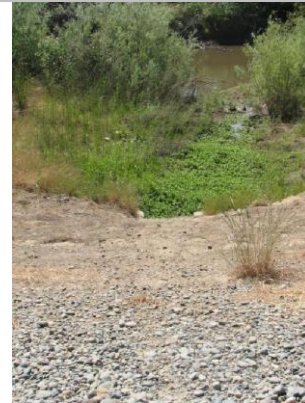
Photo 2 of 3 : UCIP_SP_2018_52212_66845.jpg

FS_ID:52212
DS_ID:16354
EP_NO: N/A
Repair Type: Non-Urgent
Crossing Status: Found
UCIP Comments: 6/14/2017 LS slide gate stem still bent. WS appeared to be in good condition. Pipe has been selected to be internally cleaned and inspected as part of the DMP project. (DWR Sutter Yard- A Freitag)11/16/2016 Screw gate stem bent but gate is still operational. (DWR Sutter Yard- A Freitag)4/28/2106 Tested positive closure device the bent stem on the slide gate did not seem to affect its functions. Gate operable.7/13/2015 LS screw gate stem is still bent. Gate should still be able to close fully. The rest of the crossing seems to be in good condition.5/21/2014 Same as last inspection.12/2/2013 Same as last inspection.7/15/2013 Slopes have been cleared of vegetation and are in good condition. LS screw gate stem is still bent.4/18/2012 LS slide gate stem is bent and needs to be replaced. Limited inspection on WS and LS slope due to dense vegetation. Need photos of cleared slopes during next inspection. Confirmed flap gate on WS. This crossing was listed in the USACE Periodic Inspection report as Corp's inspect ID#USACE_CESPK_M13D_2011_p_0244 for submerged WS gate. FIELD_STRUCT_DESC: 24-inch corrugated metal drainage pipe through the levee, 11.2 feet below the crown. Flap gate on the waterside (WS) end. Slide gate on the landside (LS) end. Concrete "U" headwall on both ends. [Additional Reference(s): DWR Levee Log, 1993. USACE Sacramento O&M Manual 519, June 1962 (HLM 7.34)]

View of WS slope and toe.

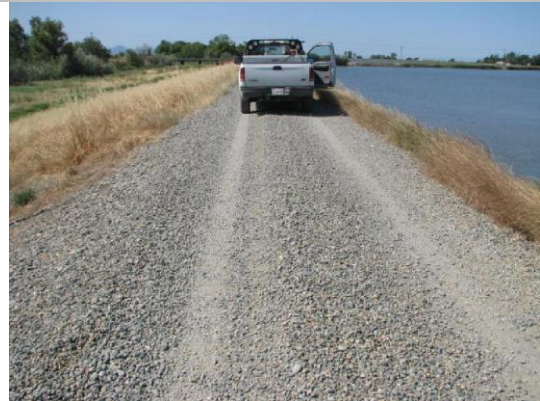
Photo 1 of 3 : UCIP_SP_2018_52213_66853.jpg

FS_ID:52213
DS_ID:16352
EP_NO: N/A
Repair Type: No Action Needed
Crossing Status: Found
UCIP Comments: 6/14/2017 Crossing appears to be in good condition. Pipe has been selected to be internally cleaned and inspected as part of the DMP project. (DWR Sutter Yard- AFreitag)11/16/2016 Crossing appears to be in good condition. (DWR Sutter Yard- AFreitag)4/28/2016 Crossing appears to be in good condition. 7/13/2015 WS ditch is getting to be heavily vegetated but it is not yet affecting flap gate operation. Vegetation needs to be cleared back some. 5/21/2014 Same as last inspection. 12/2/2013 Same as last inspection. 7/15/2013 Slopes have been cleared of vegetation and are in good condition. 4/18/2012 Limited inspection on WS and LS slopes due to dense vegetation. Need photos of cleared WS and LS slopes during next inspection.
FIELD_STRUCT_DESC: 24-inch corrugated metal drainage pipe through the levee, 10.2 feet below the crown. Flap gate on the waterside (WS) end. Screw gate on the landside (LS) end. Concrete headwall on both ends. [Additional Reference(s): DWR Levee Log, 1993. USACE Sacramento O&M Manual 519, June 1962 (HLM 7.58)]

View of levee crown at crossing looking D/S.

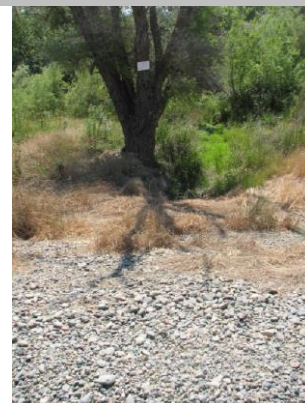
Photo 2 of 3 : UCIP_SP_2018_52213_66851.jpg

WS view of slope and channel.

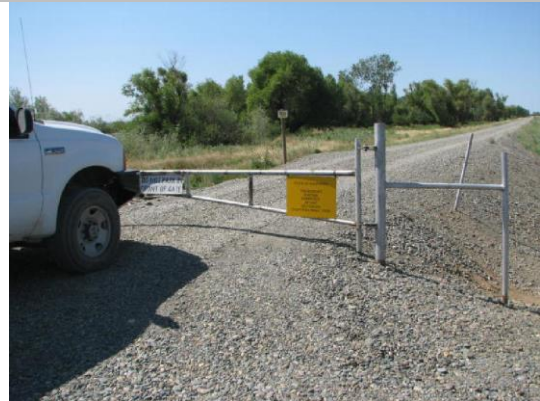
Photo 1 of 3 : UCIP_SP_2018_52217_66867.jpg

FS_ID:52217
DS_ID:16320
EP_NO: N/A
Repair Type: No Action Needed
Crossing Status: Found
UCIP Comments: 6/14/2017 Debris down inside of WS riser. The rest of the crossing appears to be in good condition. Pipe has been selected to be internally cleaned and inspected as part of the DMP project. (DWR Sutter Yard- AFreitag)11/16/2016 Crossing appears to be in good condition. (DWR Sutter Yard- AFreitag)4/28/2016 Crossing appears to be in good condition.7/13/2015 The bottom of the entire pipe has about 8inch of sediment in it. Sediment is preventing the screw gate from fully closing. WS flap gate seems to be in good condition.5/21/2014 Same as last inspection.12/3/2013 Same as last inspection.7/15/2013 Same as last inspection.
FIELD_STRUCT_DESC: 48-inch corrugated metal drainage pipe through the levee, 9.9 feet below the crown. Flap gate on the waterside (WS) end. Slide gate in corrugated metal pipe riser on the WS slope. Concrete "U" headwalls on both ends. Spillway grouted for 35 feet. [Additional Reference(s): DWR Levee Log, 1993. USACE Sacramento O&M Manual 519, June 1962 (HLM 7.76)]

Overview of levee crown at crossing (past gate) looking D/S.

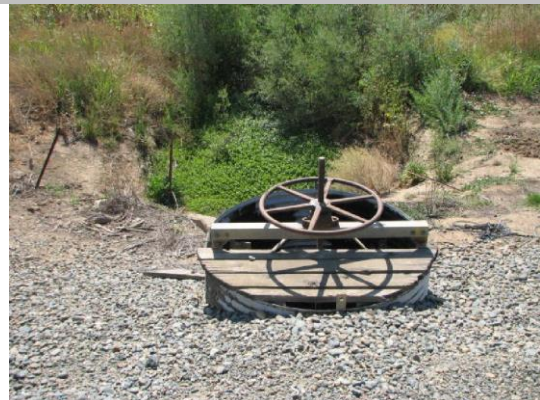
Photo 2 of 3 : UCIP_SP_2018_52217_66865.jpg

View of WS slope, corrugated metal riser with slide gate.

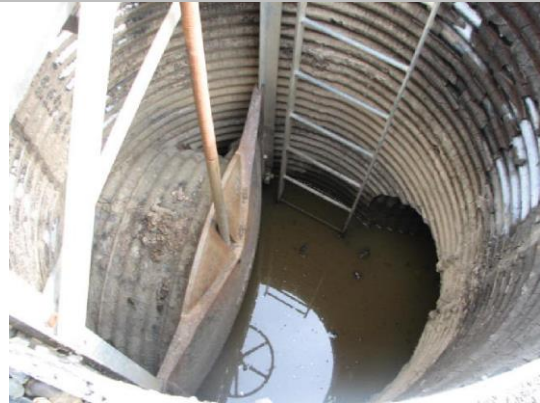
Photo 3 of 3 : UCIP_SP_2018_52217_66863.jpg

FS_ID:52217
DS_ID:16320
EP_NO: N/A
Repair Type: No Action Needed
Crossing Status: Found
UCIP Comments: 6/14/2017 Debris down inside of WS riser. The rest of the crossing appears to be in good condition. Pipe has been selected to be internally cleaned and inspected as part of the DMP project. (DWR Sutter Yard- A/Freitag)11/16/2016 Crossing appears to be in good condition. (DWR Sutter Yard- A/Freitag)4/28/2016 Crossing appears to be in good condition.7/13/2015 The bottom of the entire pipe has about 8inch of sediment in it. Sediment is preventing the screw gate from fully closing. WS flap gate seems to be in good condition.5/21/2014 Same as last inspection.12/3/2013 Same as last inspection.7/15/2013 Same as last inspection.
FIELD_STRUCT_DESC: 48-inch corrugated metal drainage pipe through the levee, 9.9 feet below the crown. Flap gate on the waterside (WS) end. Slide gate in corrugated metal pipe riser on the WS slope. Concrete "U" headwalls on both ends. Spillway grouted for 35 feet. [Additional Reference(s): DWR Levee Log, 1993. USACE Sacramento O&M Manual 519, June 1962 (HLM 7.76)]

WS Slide gate

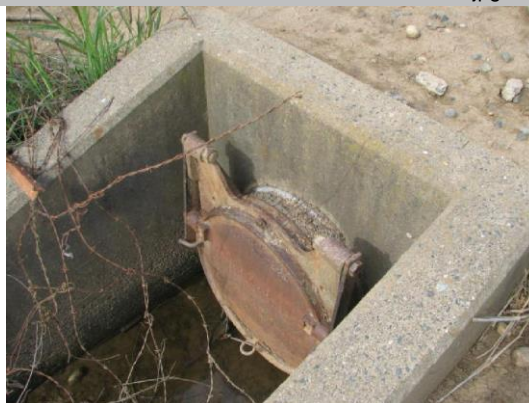
Photo 3 of 3 : UCIP_SP_2018_52218_66869.jpg

WS Flap gate

Comment Code					
Inspector Comment					
<p>FS_ID:52218 DS_ID:16321 EP_NO: N/A Repair Type: No Action Needed Crossing Status: Found UCIP Comments: 6/14/2017 Crossing appears to be in good condition. Pipe has been selected to be internally cleaned and inspected as part of the DMP project. (DWR Sutter Yard- AFreitag)11/16/2016 Crossing appears to be in good condition. (DWR Sutter Yard- AFreitag)4/28/2016 Crossing appears to be in good condition.7/13/2015 Crossing appears to be in good condition.</p> <p>5/21/2014 Same as last inspection.12/3/2013 Same as last inspection.7/15/2013 Same as last inspection.4/18/2012 Sediment build up against flashboards. Flashboards are in use on landside of levee.</p> <p>FIELD_STRUCT_DESC: 24-inch corrugated metal drainage pipe through the levee, 8.2 feet below the crown. Flap gate on the waterside (WS) end. Concrete "U" headwalls on both ends. Flashboards should be present on the landside (LS). [Additional Reference(s): DWR Levee Log, 1993. USACE Sacramento O&M Manual 519, June 1962 (HLM 8.12)]</p> <p>FS Date: 6/19/2017 12:45:23 PM</p>

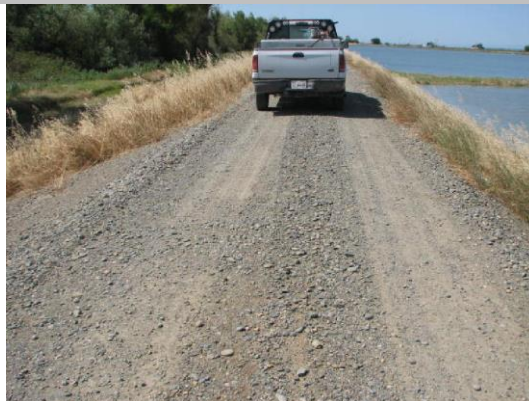
Photo 1 of 3 : UCIP_SP_2018_52219_66876.jpg

FS_ID:52219
DS_ID:16322
EP_NO: N/A
Repair Type: Non-Urgent
Crossing Status: Found
UCIP Comments: 6/14/2017 Both sides of the crossing were buried with sediment- needs to be cleared away. Pipe has been selected to be internally cleaned and inspected as part of the DMP project. (DWR Sutter Yard- A Freitag) 11/16/2016 WS flap gate is closed but is blocked from opening by sediment. (DWR Sutter Yard- A Freitag) 4/28/2016 Crossing appears to be in good condition. 7/13/2015 Minor sediment build up blocking flap gate from opening on WS. Needs to be dug out. 5/21/2014 Same as last inspection. 12/3/2013 Same as last inspection. 7/15/2013 Slopes are cleared of vegetation and are in good condition. WS flapgate is blocked from opening fully by sediment. 4/18/2012 Sediment build up on LS. Debris (broken panels) scattered near LS headwall. Limited inspection on WS and LS slope due to dense vegetation. Need photos of cleared WS and LS slopes.

Overview of levee crown at crossing looking D/S.
